Heading for 30 000 Operating Hours on HFO GenSets

CP Ships (UK) Limited has achieved a very promising 24 000 hours operating interval with MAN B&W Holeby L28/32H GenSets, and the owner is now heading for 30 000 hours before the main overhaul.

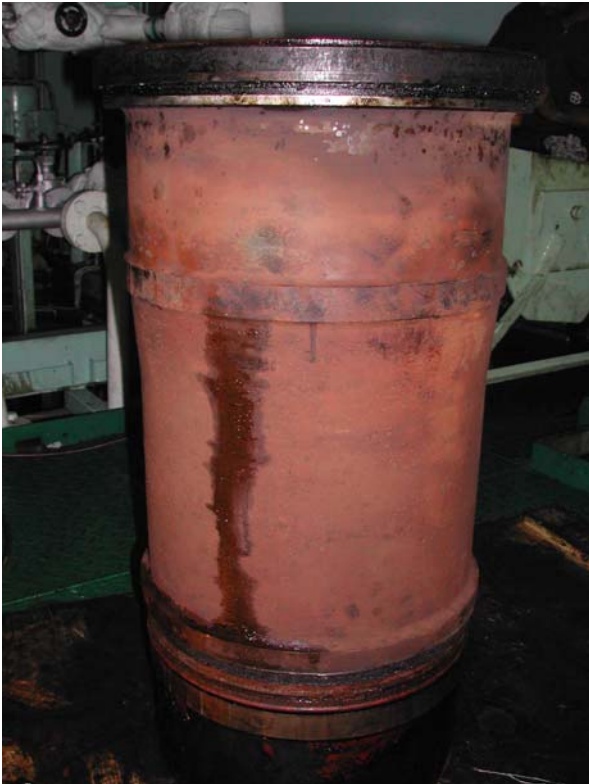
Fig. 10: Cooling water-side of cylinder liner. Cylinder liner O-rings for the cooling water spaces were renewed after inspection and cleaning

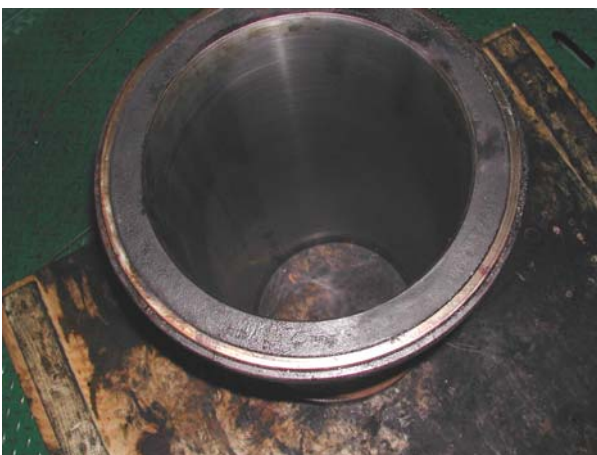
Fig. 11: Cylinder liner after cleaning

B) Liner calibration – before honing:

Position from top	1	2	3
Measured port/stbd	280.04	280.05	280.03
Measured fwd/aft	280.05	280.03	280.04

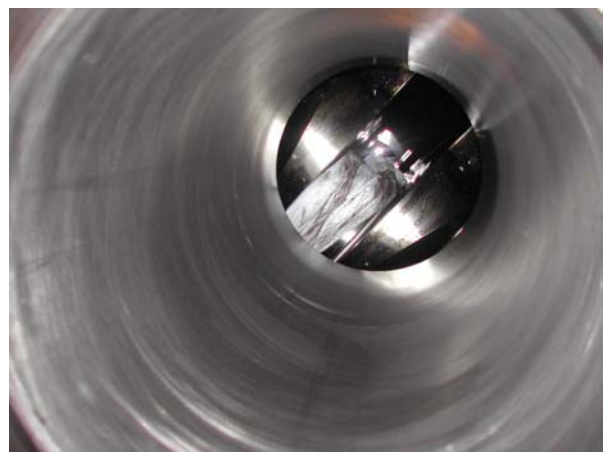
Fig. 12: Cylinder liner after the honing process

G) Liner calibration – after honing:

Position from top	1	2	3
Measured port/stbd	280.05	280.04	280.03
Measured fwd/aft	280.05	280.04	280.04

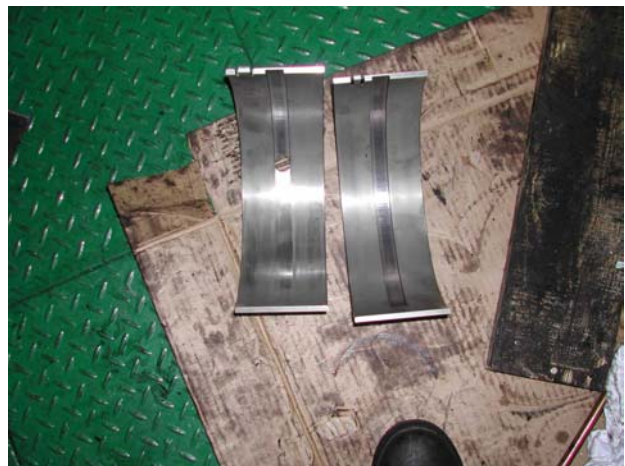
Fig. 16: Bearing shells ready for fitting
